**RAILWAY INVESTIGATION REPORT**  
**R05V0141**

**DERAILMENT**

**CANADIAN NATIONAL**  
**FREIGHT TRAIN A47151-05**  
**MILE 56.6, SQUAMISH SUBDIVISION**  
**GARIBALDI, BRITISH COLUMBIA**  
**05 AUGUST 2005**

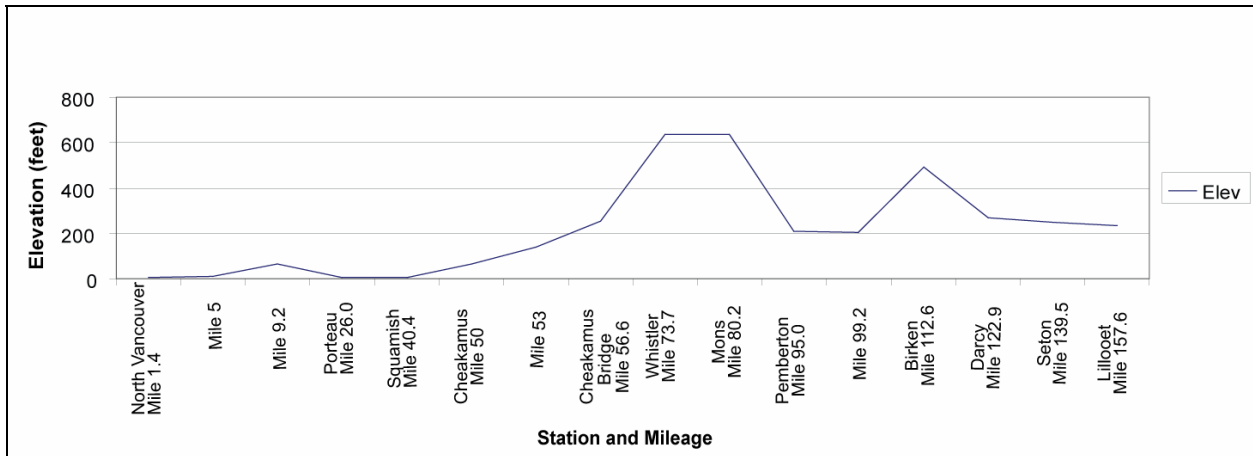
Figure 2 shows the track profile along the subdivision.

Figure 2. Squamish Subdivision elevation profile (train proceeding from left to right)

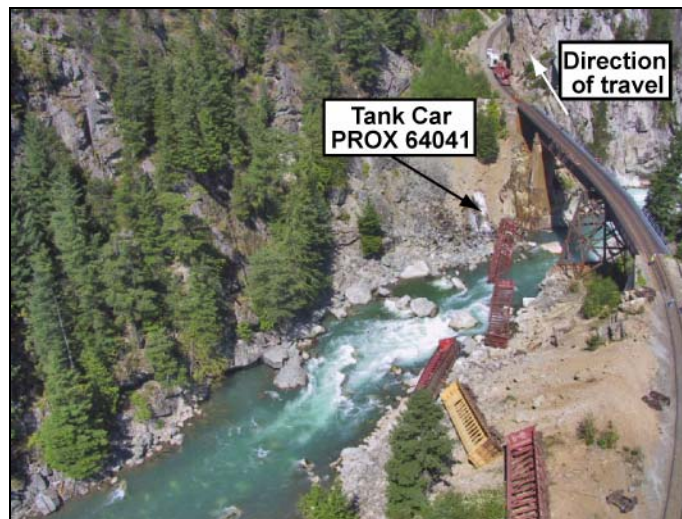
After making the necessary emergency broadcast and notifying the RTC, the conductor initiated an inspection of the train, discovering that nine cars (the 4th to the 12th) had derailed to the west (inside) of the 12-degree 20-minute left-hand curve at the Cheakamus River Bridge. A total of four cars had fallen off the bridge; tank car PROX 64041, a load of 73 per cent concentration sodium hydroxide (4th car), and three empty centre beam flat cars. The tank car struck the concrete bridge pier and landed on the north bank of the river (see Photo 1) and the three empty centre beam flat cars behind it landed on their sides on the river bed. The four derailed cars following, three empty centre beam flat cars and an empty wood chip gondola car, were on their sides. The 12th car, an empty wood chip gondola, was upright, with only the B-end<sup>4</sup> (north) end derailed.

**Photo 1.** Tank car position after the derailment

Tank car PROX 64041 was a non-pressure tank car, type 111A100W3, built in November 1984. The derailed tank car fell off the west side of the Cheakamus River Bridge, onto the north bank, and came to rest on its right side with the manway facing downstream at an angle of about 30 to 35 degrees. The jacket was severely damaged and damage to the tank itself was most severe at the AL location, which at this point, was the top corner of the lower (downhill) end of the tank. All valves and the manway cover had been sheared off the car. The manway had also been dented at the A-end. The trucks separated from the car and most of the rigging and safety appliances were gone. Spilled product had coated the entire top of the car as well as most of the surrounding area to about 20 m upstream and 25 m downstream.
